TROUBLE-SHOOTING GUIDE FOR RITCHIE FROST FREE HYDRANTS

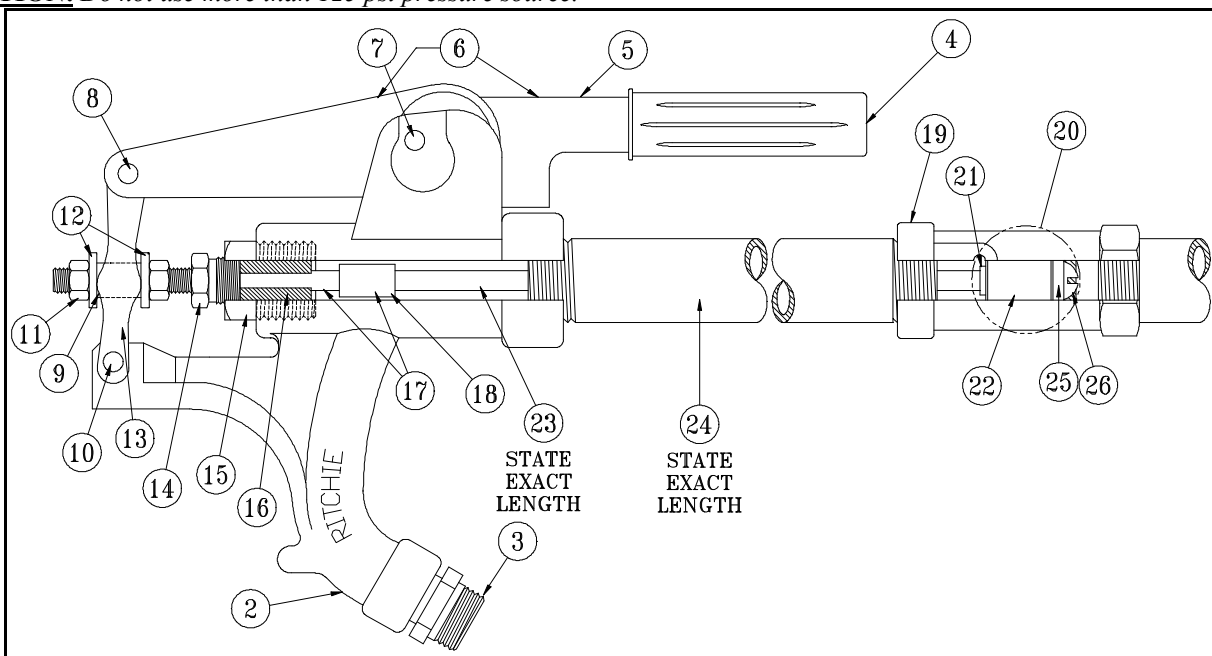
1. If hydrant continues to drip after handle is closed, the plunger rod may need to be adjusted.
 - a. Loosen hex nut #11, on top of plunger rod #17
 - b. Open the hydrant handle #5 partially to relieve pressure on plunger rod.

- e. Close hydrant handle. Check for leaks.
2. If hydrant continues to drip after adjusting the plunger rod, the leather washer #25 on the plunger assembly #20 needs to be replaced. **NOTE:** *This can be done without removing hydrant from ground.*

3. If hydrant continues to leak, after replacing plunger assembly, the valve chamber #19 needs to be replaced. **NOTE:** *The hydrant must be removed from ground for this repair.*

4. If hydrant leaks around plunger rod #17 in hydrant head, the brass packing nut #14 may need adjusting.
 - a. Tighten brass packing nut #14 into plastic packing gland fitting #15, approximately $\frac{1}{4}$ turn at a time.

5. If hydrant freezes in the winter, the drain weep hole in the valve chamber #19 is plugged, the valve is leaking, or the ground water level is too high. If drain hole is plugged, it may be possible to clean it out, by back flushing after the hydrant is unfrozen. This can be done, by connecting a pressurized water or air source to the hydrant outlet hose fitting #3, while the handle is closed.
